The fire resistance performance of four vertical penetration sealing systems and four horizontal penetration sealing systems when tested in accordance with BS EN 1366-3: 2004

163146 Issue 2

Astroflame (Fire Seals) Limited

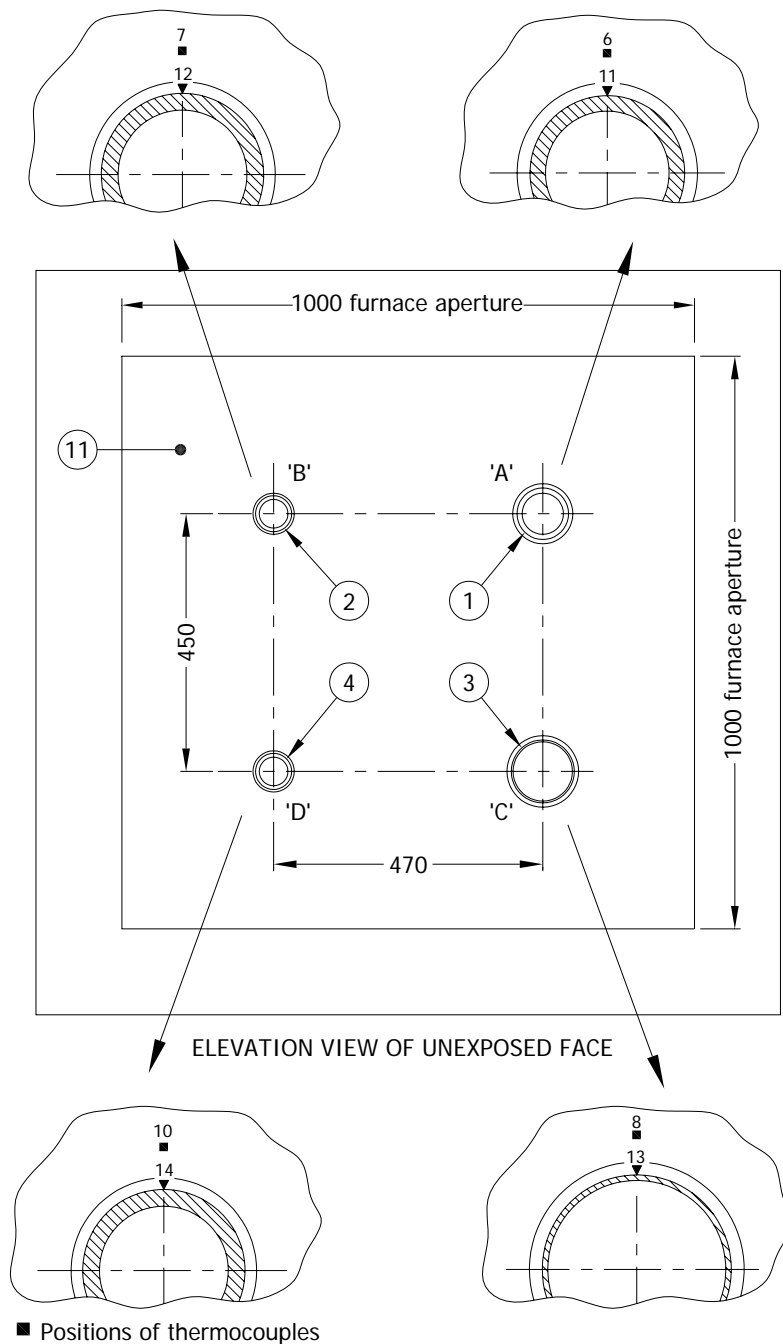
Figure 1- General Elevation of Wall Specimens and Unexposed Face Thermocouples

The wall assembly was formed from aerated autoclaved concrete blocks 150 mm thick incorporating four apertures at diameters of, two No. 72 mm (specimens B&D), 105 mm (specimen A) and 125 mm (specimen C).

(Refer to Figures 1 to 3)
(All values are nominal unless stated otherwise)
(All other details are as stated by the sponsor)

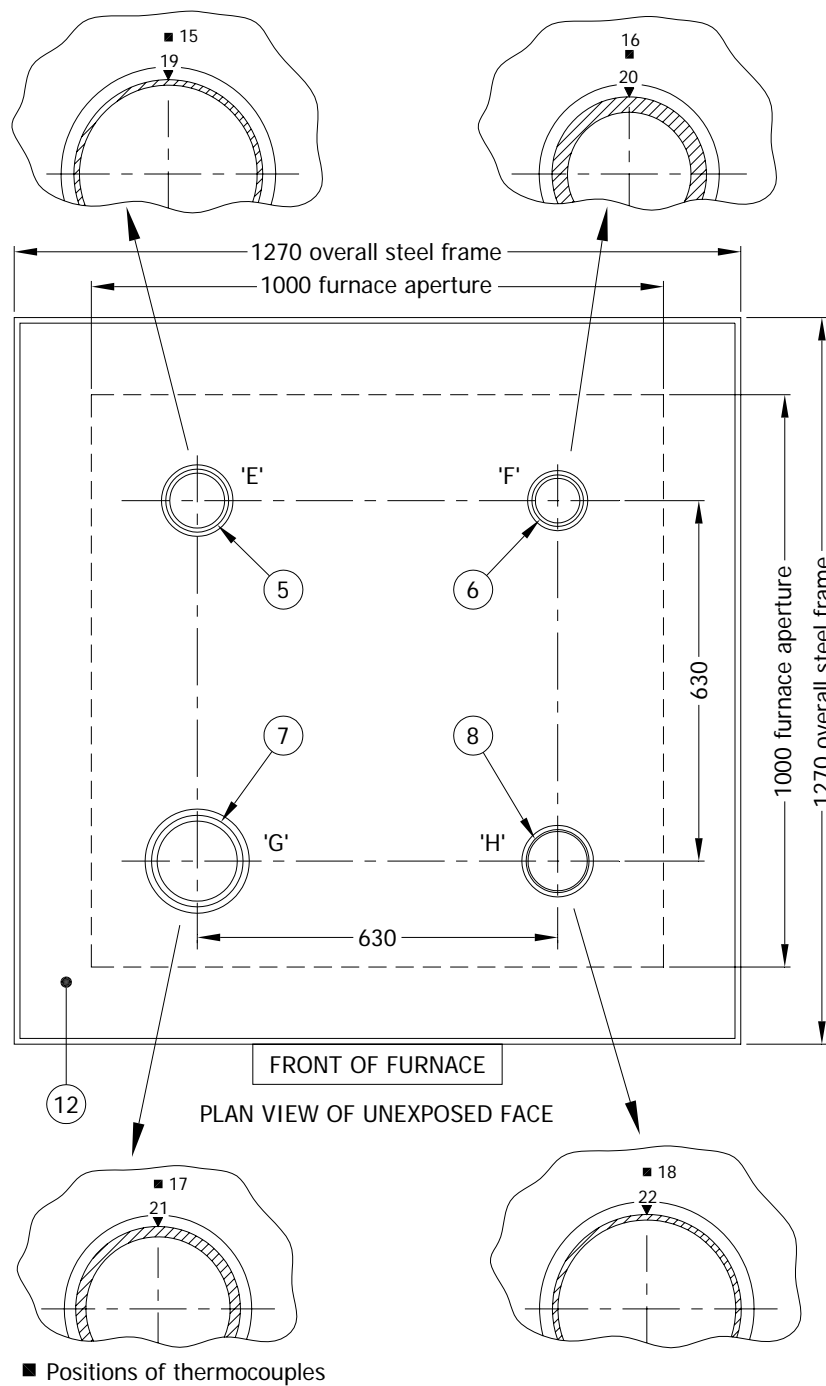
Figure 2 – General Plan of Floor Specimens and Unexposed Face Thermocouples

The floor assembly comprised a section of aerated autoclaved reinforced concrete 150 mm thick incorporating four apertures at diameters of, 105 mm (specimen F), two No. 125 mm (specimens E&H) and 182 mm (specimen G).

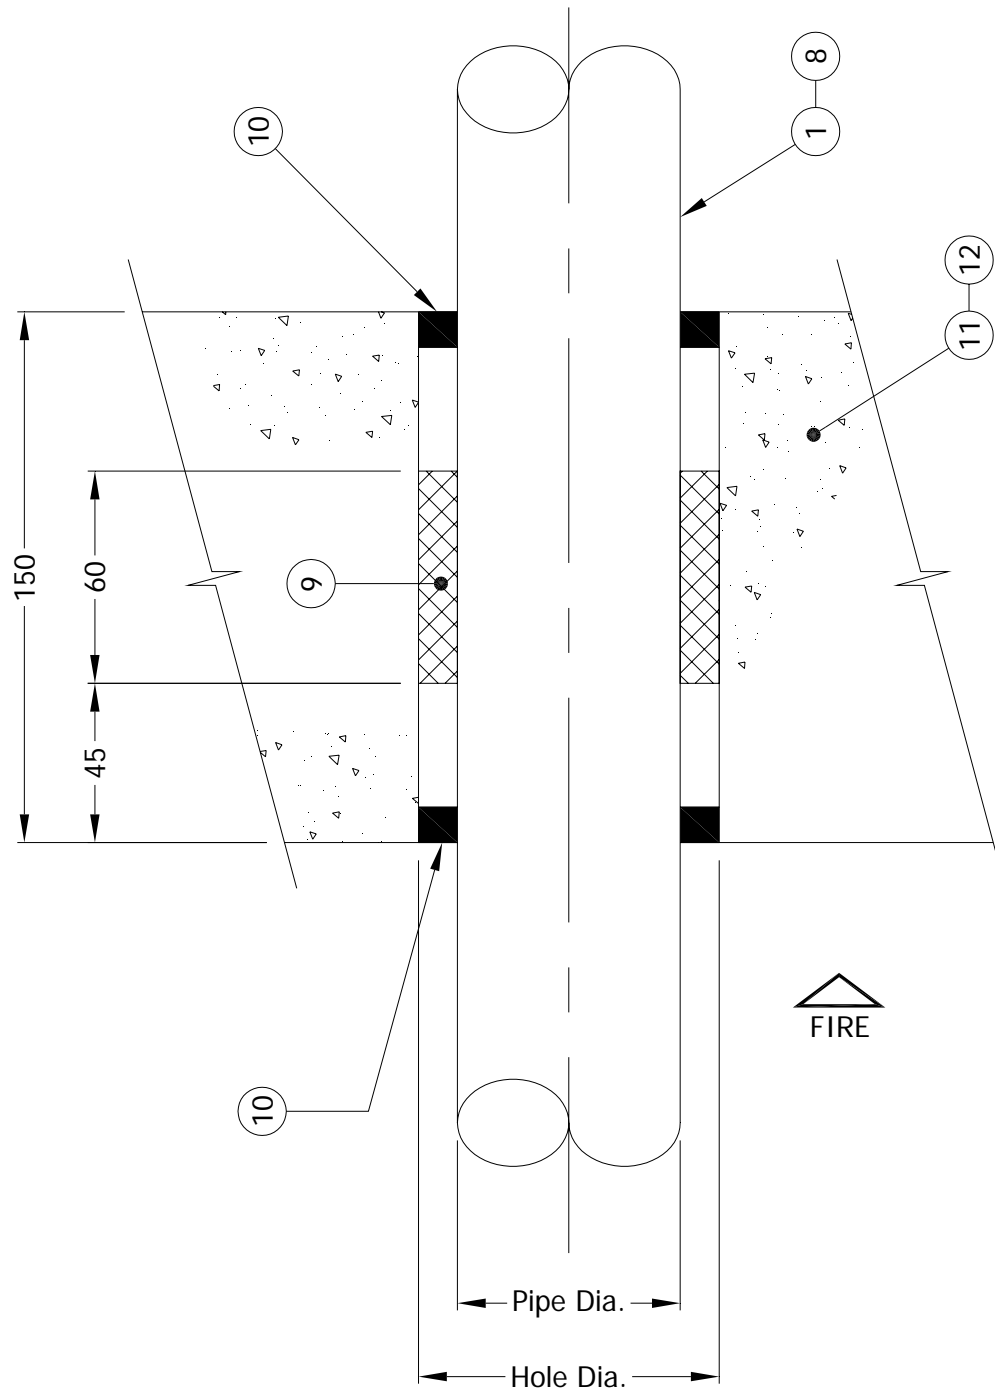
Figure 3 – Typical Pipe Penetration Details For Wall and Floor Specimens

Each aperture was penetrated with a single pipe. Each pipe was provided with an intumescent wrap, the pipe and wrap were friction fitted into the aperture so that the wrap was at mid depth of the aperture.

Specimens A, C, E & F were backfilled with 'ASTROFLAME FIRE RESISTANT MORTAR' on both faces for a depth of 5 mm. Specimens B, D, G & H were backfilled with 'ASTRO INTU MASTIC' sealant on both faces for a depth of 5mm.

9. Intumescent Sleeve	
Reference	: ASTROWRAP
Material	: Graphite based intumescent core within a polyethylene (PE) sleeve.
Overall size of intumescent core

i. specimen 'A' & 'F'	: 60 mm wide x 6 mm thick x 308 mm long
ii. specimen 'B' & 'D'	: 60 mm wide x 3.5 mm thick x 212 mm long
iii. specimen 'C' & 'E' & 'H'	: 60 mm wide x 6 mm thick x 385 mm long
iv. specimen 'G'	: 60 mm wide x 9.5 mm (6 mm + 3.5 mm layers) thick x 555 mm long.
Fixing method	: Wrapped around outside diameter of pipe (no overlap) giving a friction fit between the pipe and the drilled aperture at mid depth of the masonry wall/floor slab.

Item	Description
10. continued	
Application method	
i. mortar	: Mortar/water mix, pressed into the gap between the pipe and the drilled aperture for a depth of approximately 5 mm from both faces of the masonry wall/floor slab, using a flat blade applicator
ii. mastic	: Cartridge gunned into the gap between the pipe and the drilled aperture for a depth of approximately 5 mm from both faces of the masonry wall/floor slab.
11. Blockwork Wall	
Material	: Autoclaved aerated concrete blocks
Density	: 760 kg/m ³
Thickness	: 150 mm
Bedding material	: Ordinary sand and cement mortar
12. Concrete Floor Slab	
Material	: Autoclaved aerated concrete slab
Density	: 670 kg/m ³
Thickness	: 150 mm
Bedding material	: Ordinary sand and cement mortar

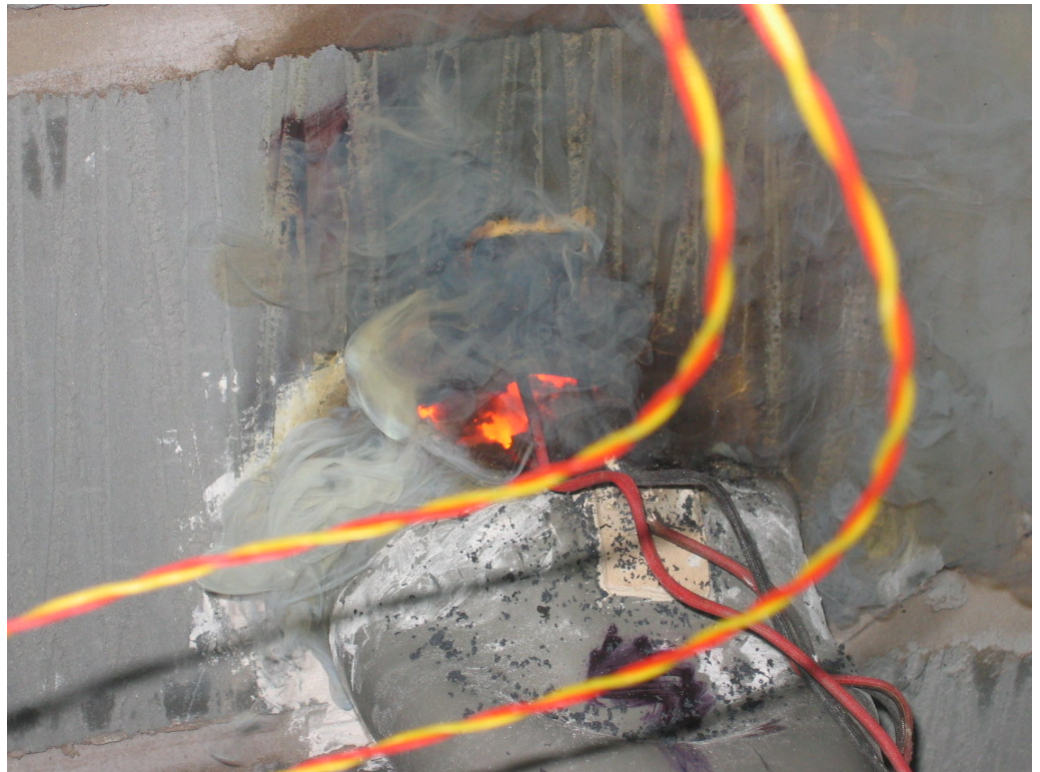
**Integrity failure
of pipe C after a
duration of 212
minutes**

160	00	Smoke issue is increasing from pipe C at area mentioned at 120 minutes, the pipe is continuing to move away from wall, approximately 30mm. Smoke issue and discolouration has occurred on both sides of the pipe, as well as at the top.
180	00	All pipes continue to satisfy all integrity and insulation criterion.
182	00	Smoke issue is increasing from pipe C.
212	00	Pipe C beginning to detach from the wall. A cotton wool pad is applied and ignited, the specimen was removed and hole was blanked off. Cotton wool pad integrity failure is deemed to have occurred.
218	00	Pipe H has started to distort around its base.

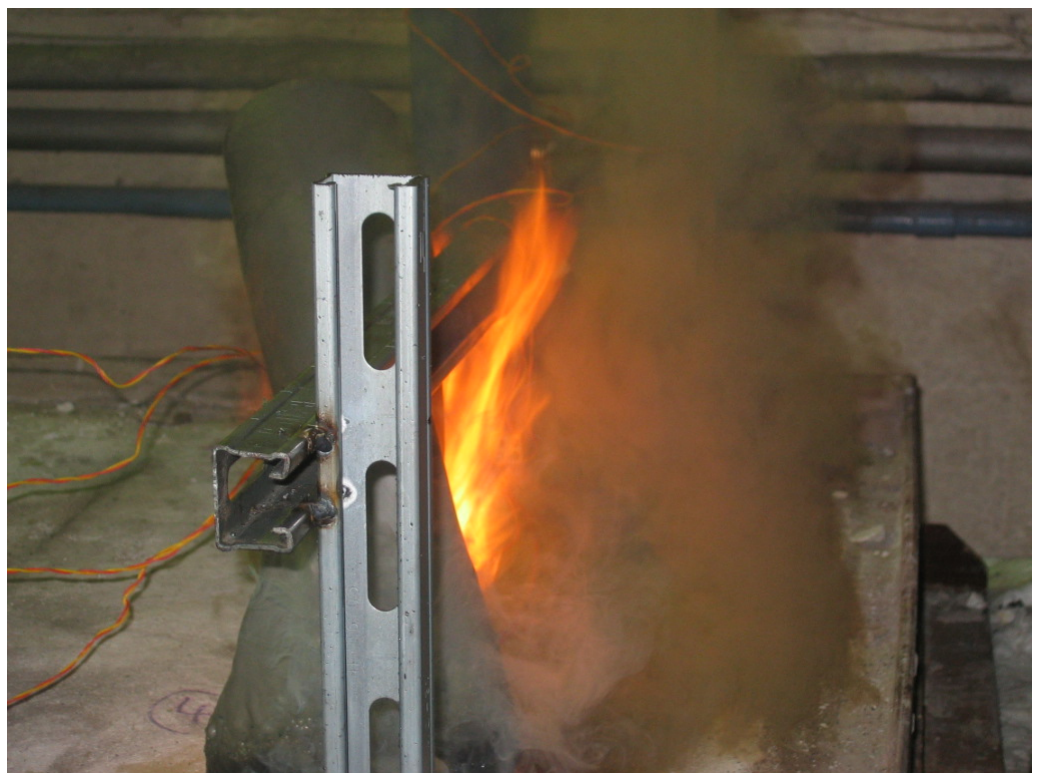
**Integrity failure
of pipe H after a
duration of 231
minutes**

Time		
mins	secs	
219	00	Glowing is visible around the seal of pipe D on the left hand side. A cotton wool pad is applied but did not ignite.
223	00	A cotton wool pad is re-applied but did not ignite.
231	00	Smoke issue is increasing from the seal of pipe H.
231	30	Sustained flaming on pipe H at the seal. Sustained flaming integrity failure is deemed to have occurred.
235	00	A cotton wool pad is re-applied to pipe D but did not ignite.
236	00	Glowing visible around pipe D from left hand side around top to the right hand side.
239	00	A cotton wool pad is re-applied to pipe D and ignited. Cotton wool pad integrity failure is deemed to have occurred.
241	00	The test is discontinued.

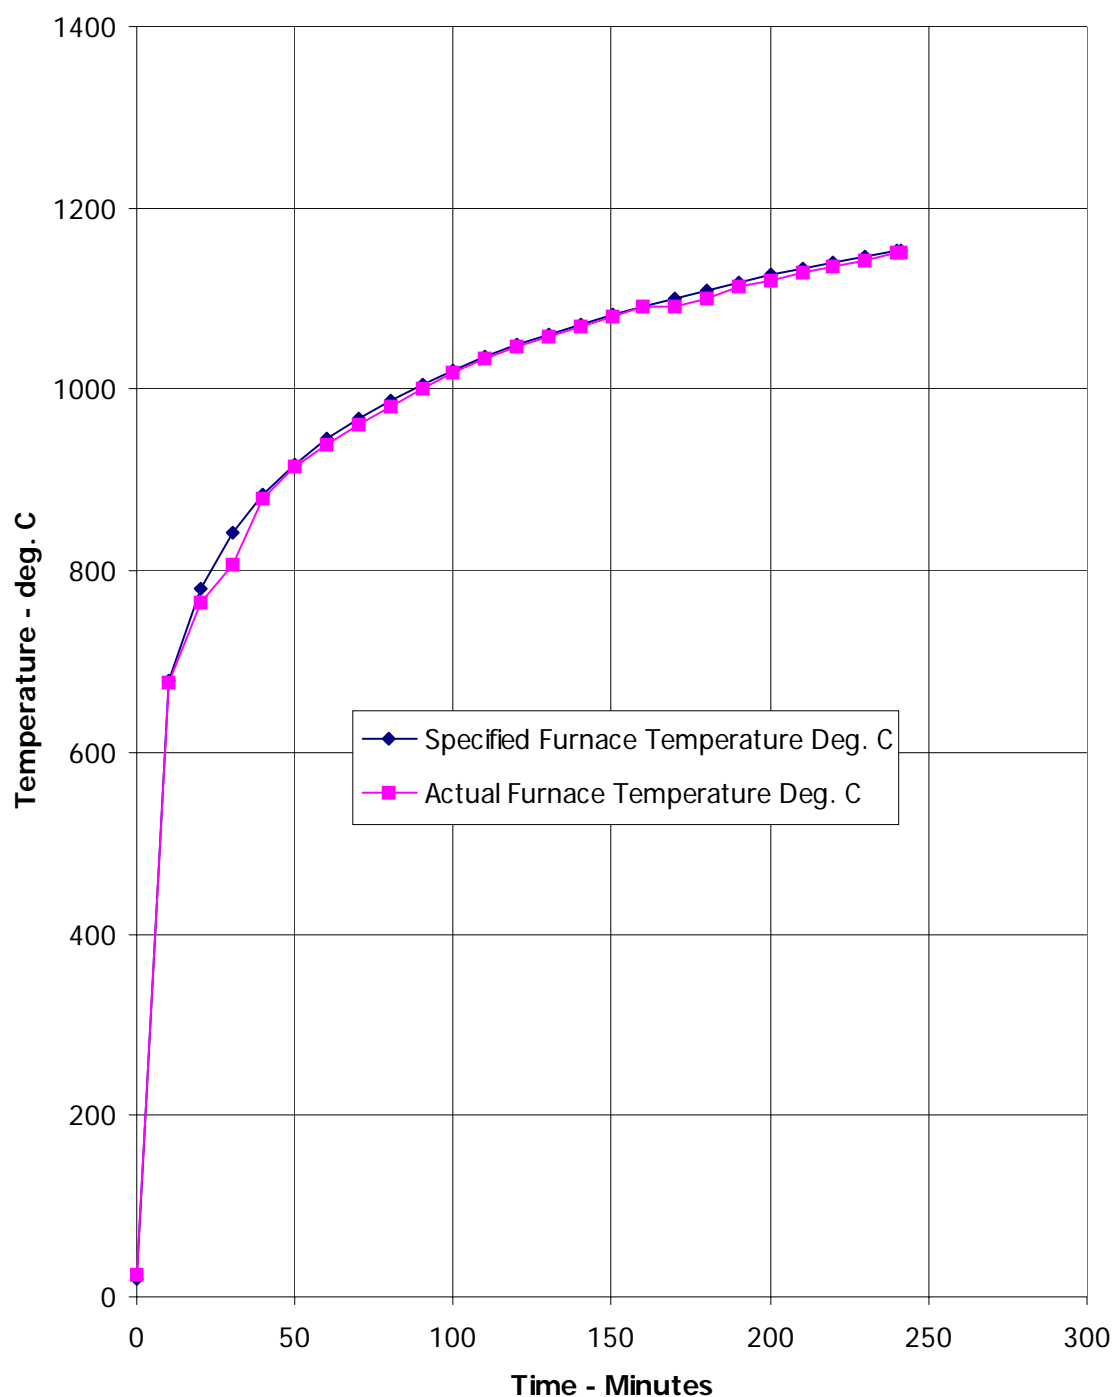
Graph Showing Mean Furnace Temperature, Together With The Temperature/Time Relationship Specified In The Standard

Time Mins	Specified Furnace Temperature Deg. C	Actual Furnace Temperature Deg. C
0	20	24
10	678	678
20	781	765
30	842	806
40	885	879
50	918	915
60	945	939
70	968	962
80	988	982
90	1006	1001
100	1022	1019
110	1036	1035
120	1049	1048
130	1061	1059
140	1072	1068
150	1082	1080
160	1092	1090
170	1101	1091
180	1110	1100
190	1118	1113
200	1126	1120
210	1133	1128
220	1140	1135
230	1146	1142
240	1153	1150
241	1153	1151

General	The instrumentation was provided in accordance with the requirements of the Standard.
Furnace	The furnace was controlled so that its mean temperature complied with the requirements of BS EN 1363-1: 1999 Clause 5.1 using three plate thermometers, distributed over a plane 100 mm from the surface of the vertical test construction.
General	<p>Thermocouples were provided to monitor the unexposed surface of the specimens. The output of all instrumentation was recorded at no less than one minute intervals as follows:</p> <p>The locations and reference numbers of the various unexposed surface thermocouples are shown in Figures 1 and 2.</p>
Roving Thermocouple	A roving thermocouple was available to measure temperatures on the unexposed surfaces of the specimens at any position, which might appear to be hotter than the temperatures indicated by the fixed thermocouples.
Integrity criteria	Cotton pads were available to evaluate the integrity of the specimens.
